Re: Compliance Evaluation Inspection of the Central District Wastewater Treatment Plant
Notice of Violation
National Pollutant Discharge Elimination System Permit No. FL0024805

COMPLIANCE EVALUATION INSPECTION REPORT

**Miami-Dade County, Florida
Water and Sewer Department
Central District (Virginia Key) Wastewater Treatment Plant
Miami, Florida
NPDES Permit No. FL0024805**

May 1-2, 2014

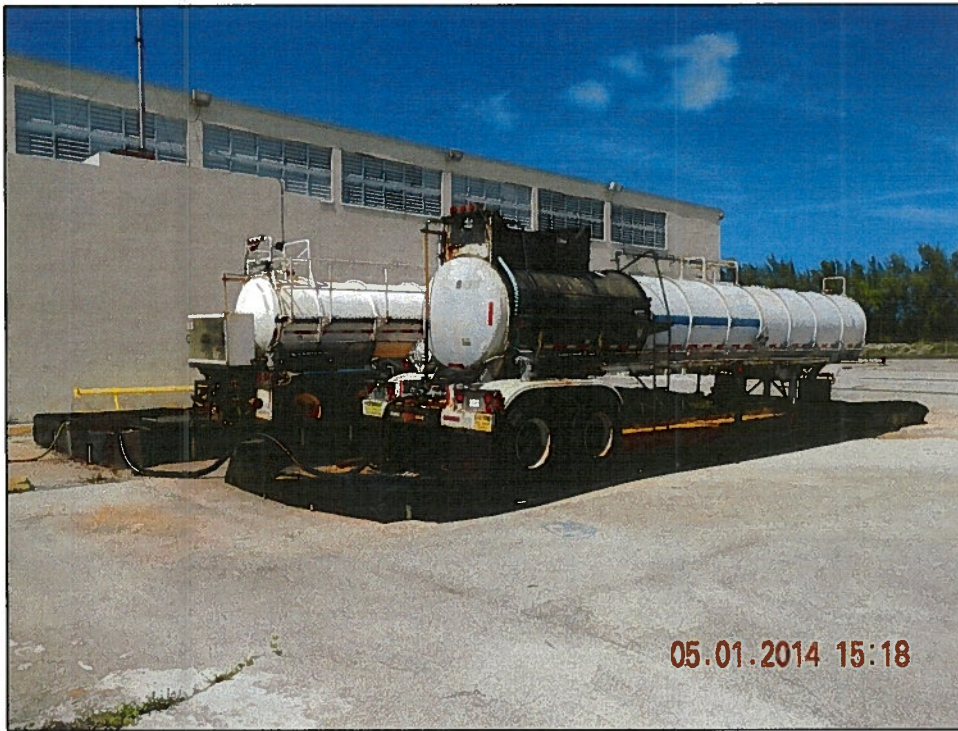
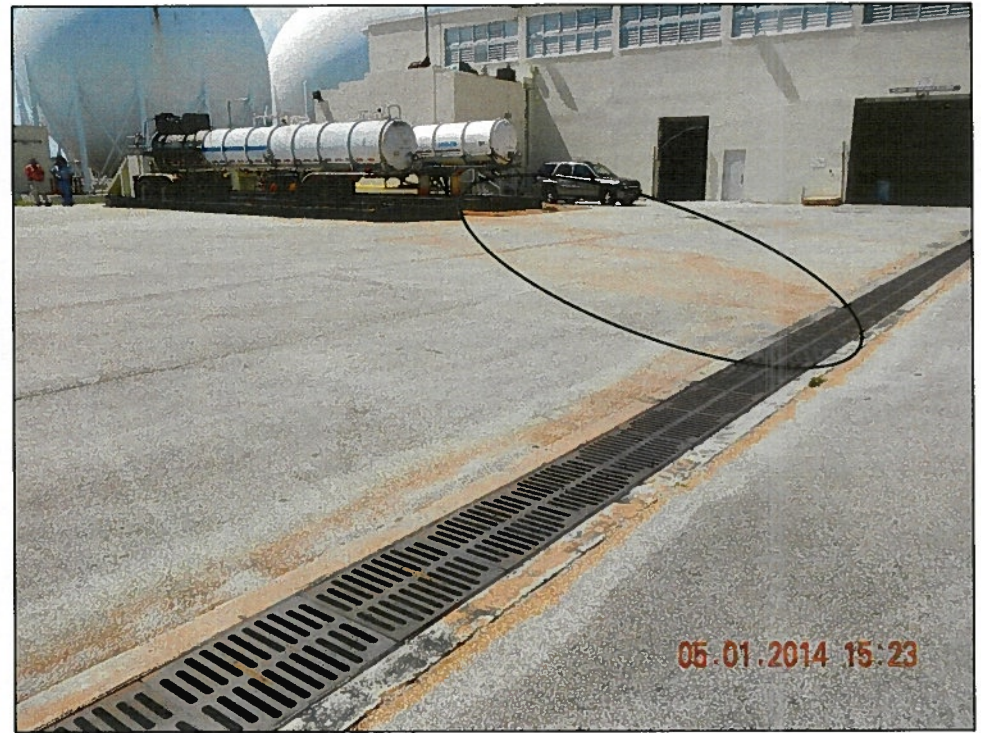
Ferric Chloride is fed into a valve box outside the Sludge Dewatering Building (prior to adding polymer) to decrease struvite creation. Two ferric chloride tankers in temporary containment were observed outside of the sludge dewatering building. Mr. Saint-Phard stated that a permanent ferric chloride building is in the works, but the contractor had been delayed in getting the necessary permits. Evidence of ferric chloride runoff to a nearby storm drain (that drains to the headworks of Plant 2) was observed. See enclosed photos.

Sludge Dewatering Ferric Chloride tankers (drain to storm drain)

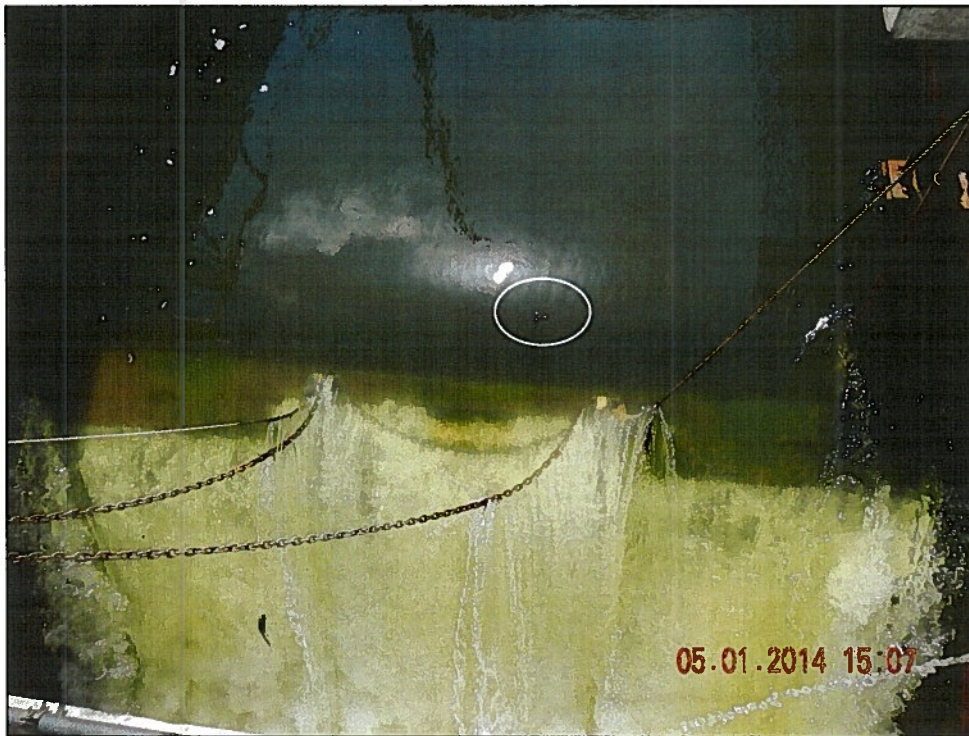
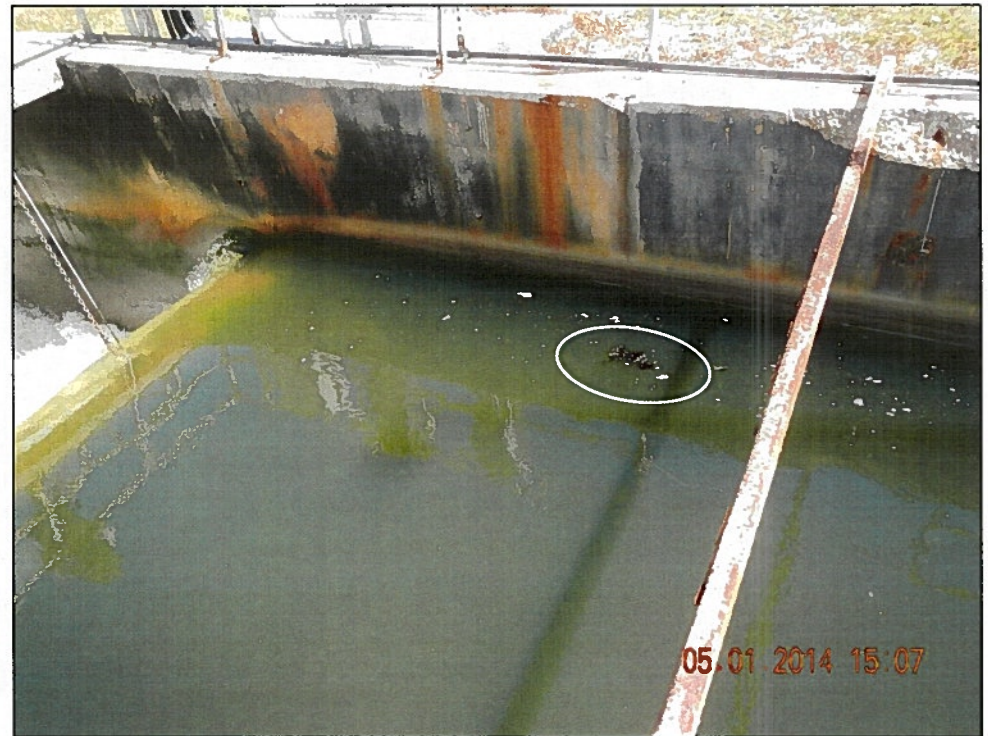
In the final settling tanks/secondary clarifiers, the EPA observed some algae and large floatables, trash/debris (e.g., plastic trash), unsettled floc and large amounts of pin floc. In addition, the EPA observed some large algae bricks being discharged out of the effluent trough of the final settling tanks. *See the enclosed photos.*

Plant 2, effluent trough at Final Settling Tank #10C (algae bricks)

Violation/Recommendation: Part II, Section B.1. of the EPA-issued NPDES permit requires the permittee to "...at all times properly operate and maintain all facilities and systems of treatment and control (and related appurtenances) which are installed or used by the permittee to achieve compliance with the conditions of this permit." Previous EPA inspections have noted similar trash, floatables, algae and pin floc in the final settling tanks/secondary clarifiers. While less of these items were noted than in previous inspections and Miami-Dade WASD appears to be implementing a regularly-scheduled cleaning of the weirs and effluent troughs between tanks, Miami-Dade should consider a SOP to capture larger algae mats as solid waste when cleaning weirs and/or effluent troughs and prevent their passage into the effluent channel [NOTE: According to an email from Miami-Dade staff on June 10, 2014, WWTP staff now catch larger debris/algae with pool nets when washing down weirs].

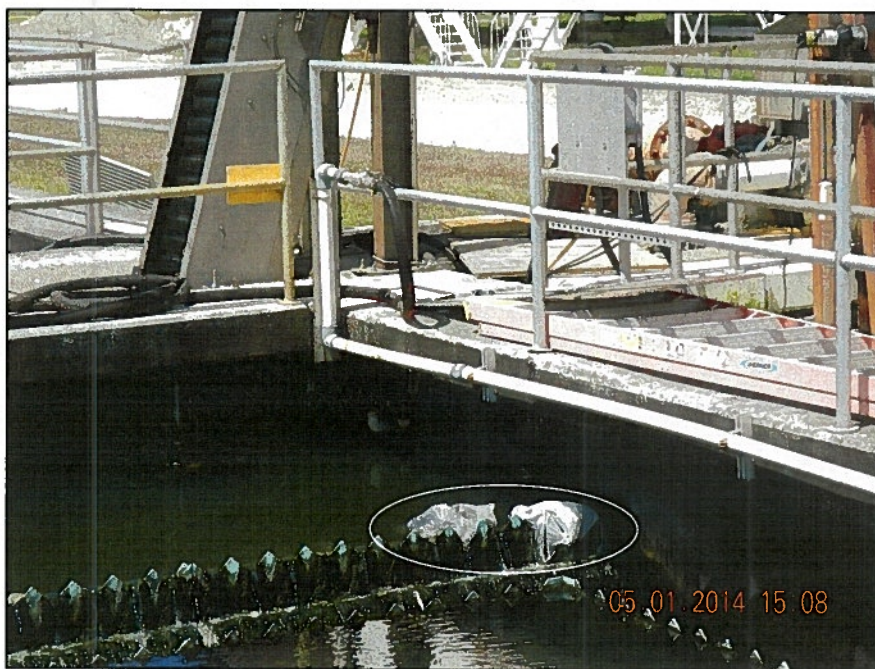
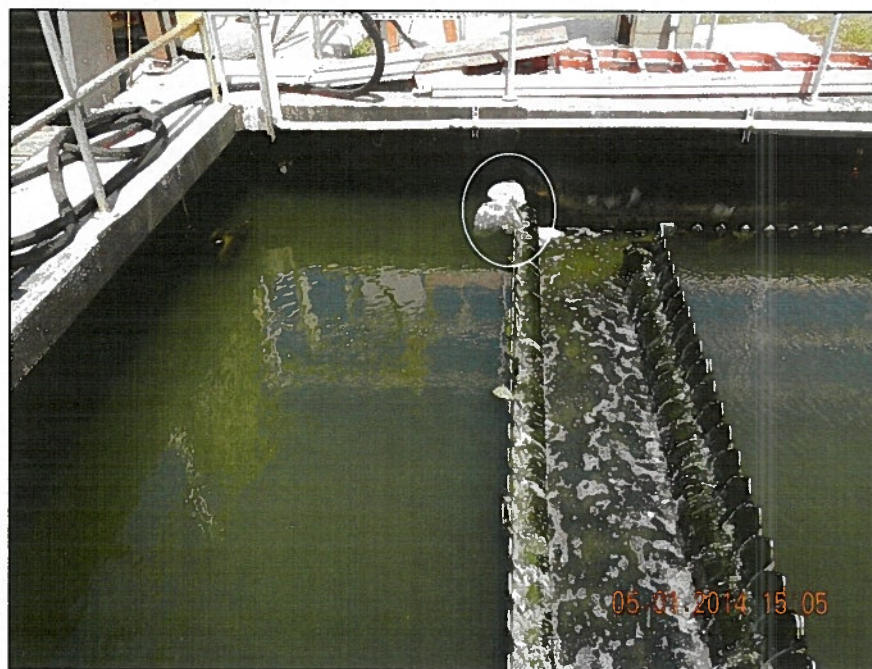
Plant 2, Final Settling Tank #10C (2 plastic bags on weirs)
